Existing Project Study

Middlebury
College

Executive Summary

This study aims to summarize Habitat for Humanity of Addison County's work as it approaches its 25th year of operation. The research and analysis explores how the houses built by the organization have changed over the years, identifying ways in which they have improved in addition to areas in which there is room for improvement. Through a careful analysis of the chapter's thirteen built houses and one house under construction, this study identifies trends across the homes to give the board more information on how to proceed in the years to come.

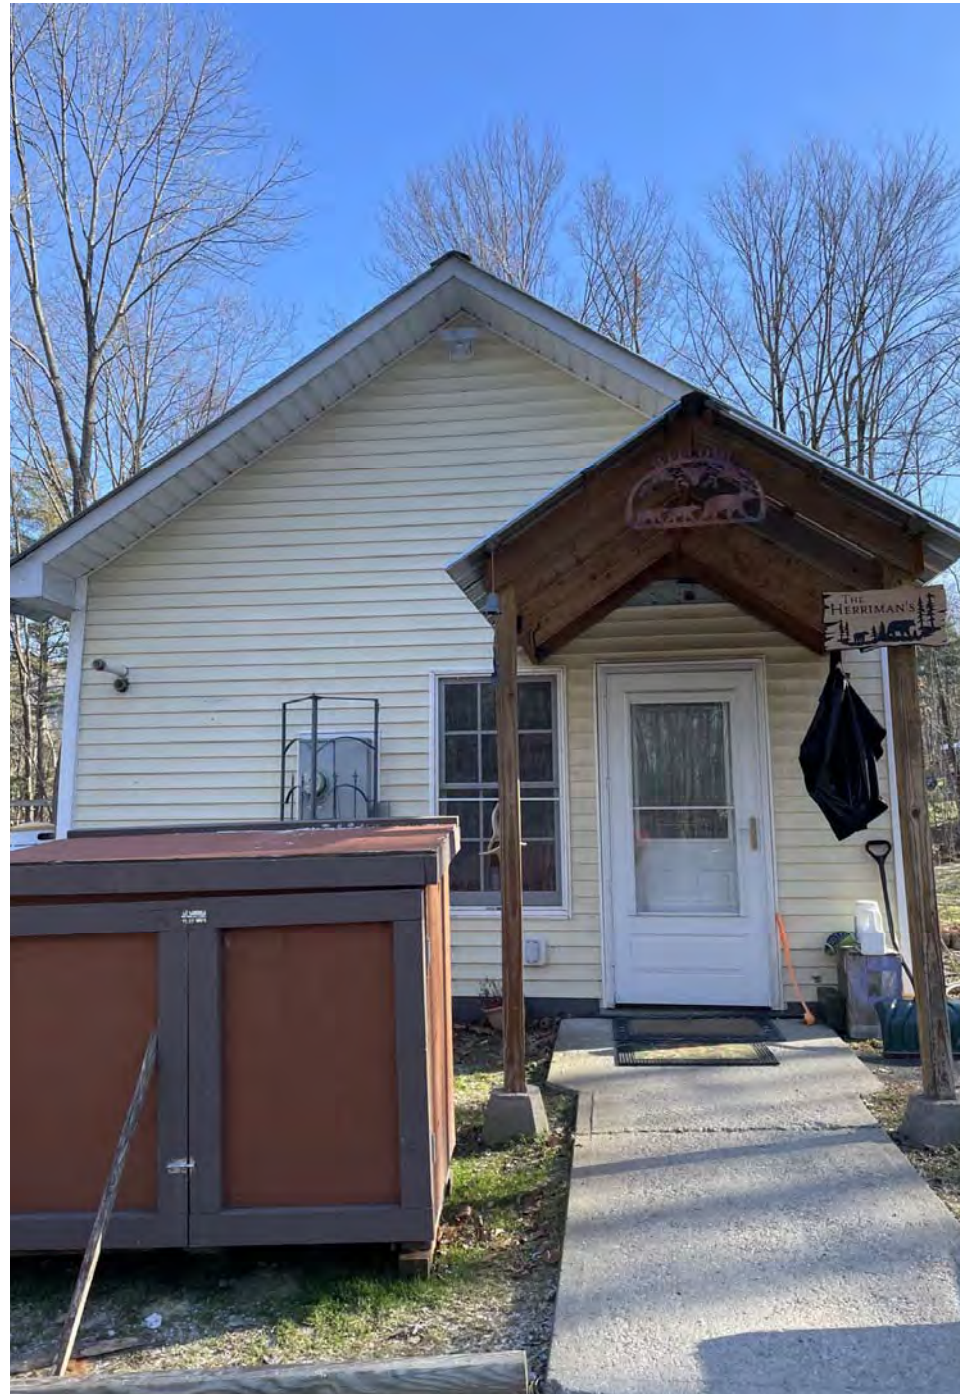
West Elevation

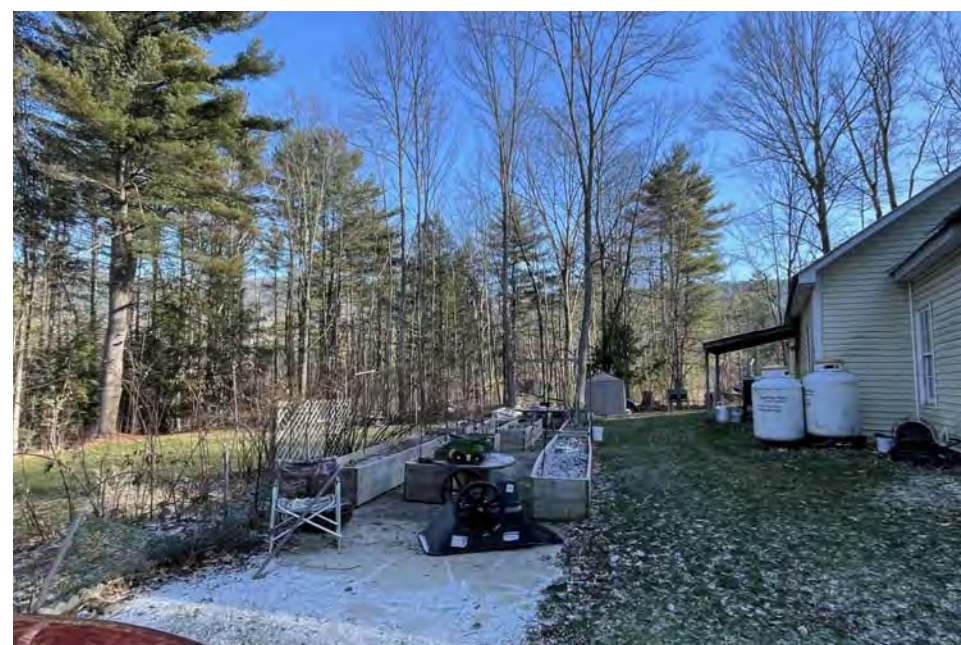
Garden on the North Side

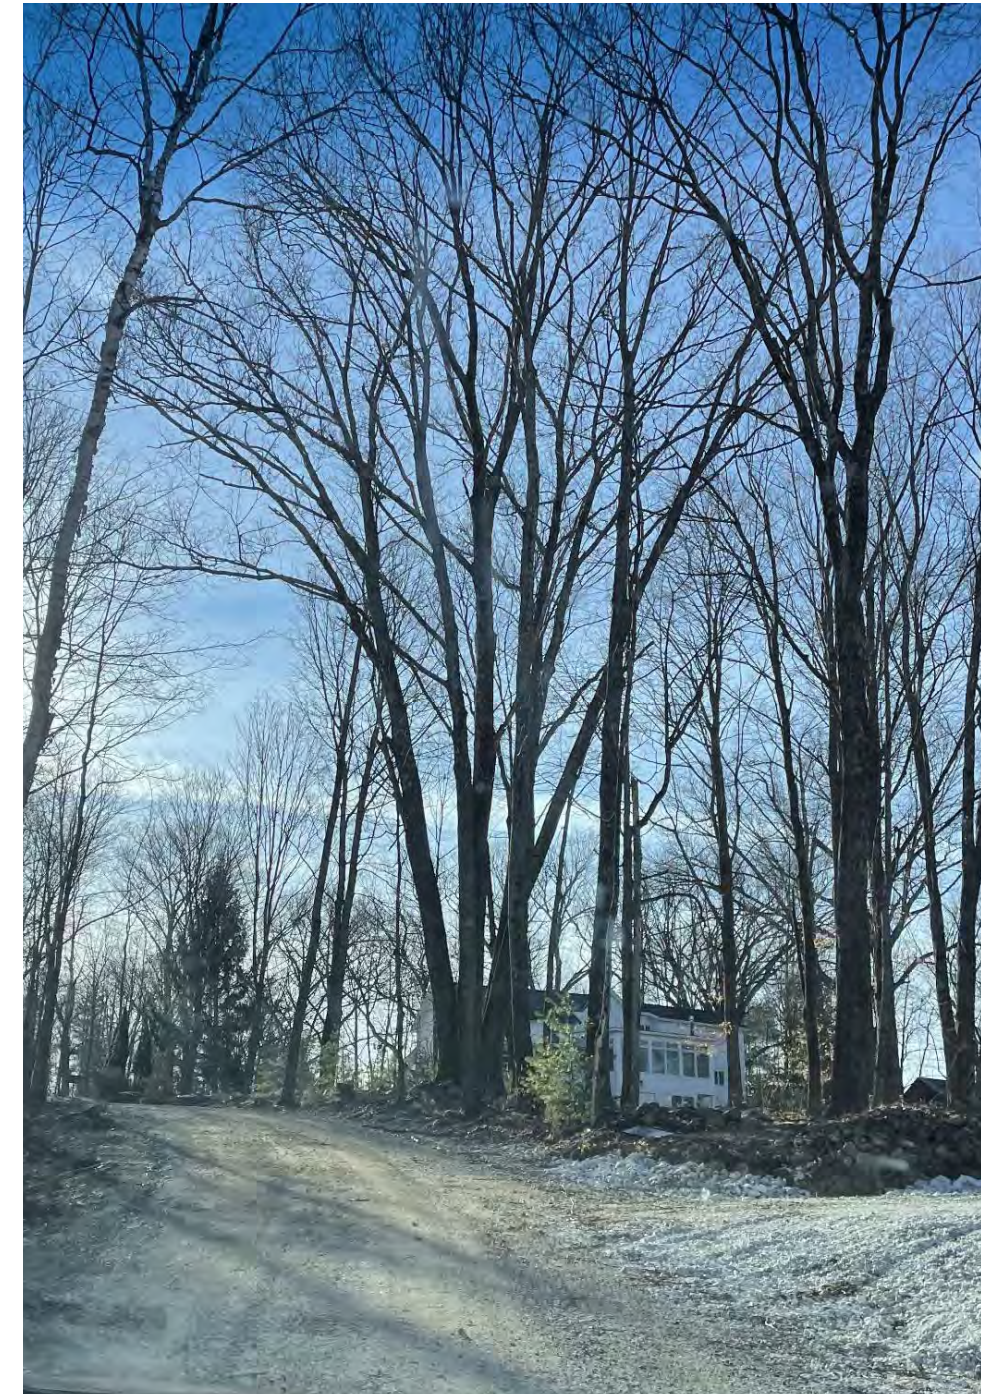
Driveway

- Found living spaces too small/compact
- Wished overhead lighting was included in the original design
- Steep and curved driveway required her to purchase a vehicle with 4 wheel-drive
- Habitat did ensure the house was wheelchair accessible for her son (widened doorways, etc.)

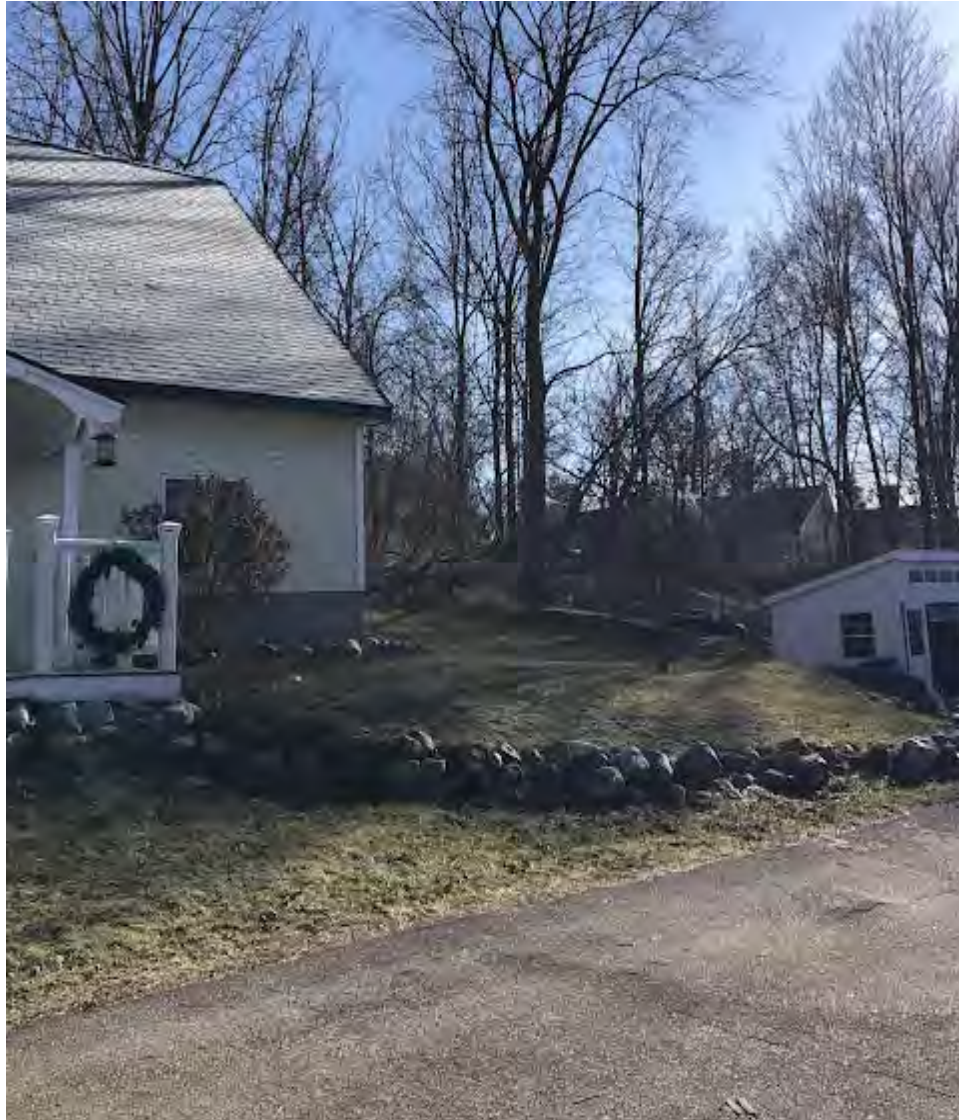
Front Yard & Landscaping

- Steep pitch of terrain facilitates drainage.
- Terraced, rocky landscaping to help prevent soil erosion while allowing water flow.

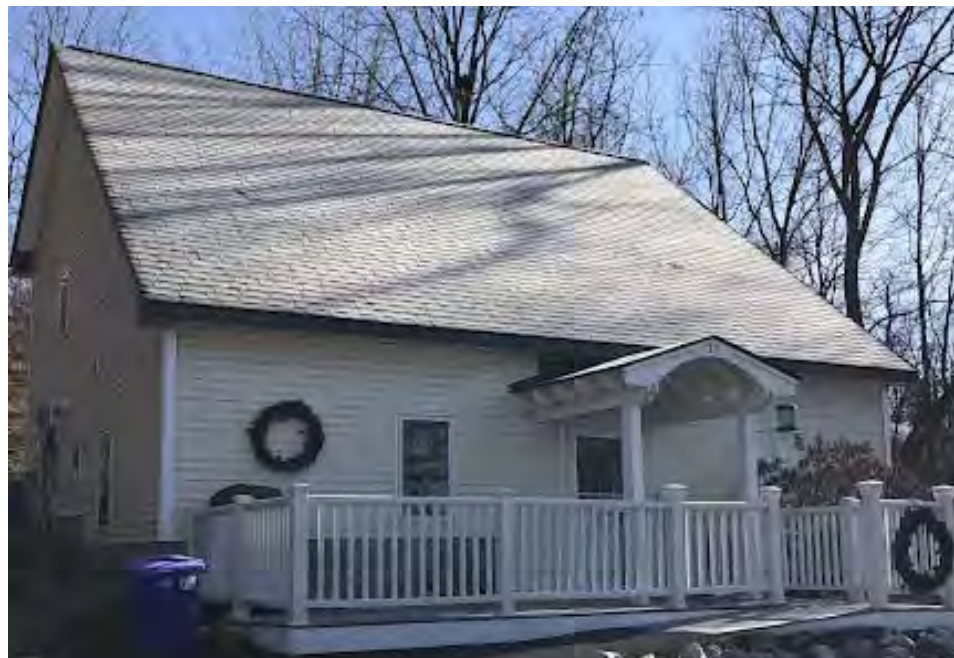
Porch Addition

- House strongly adheres to neighborhood style with similar coloration and gable-style roof.
- Wheelchair accessibility
- Homeowners likely added porch

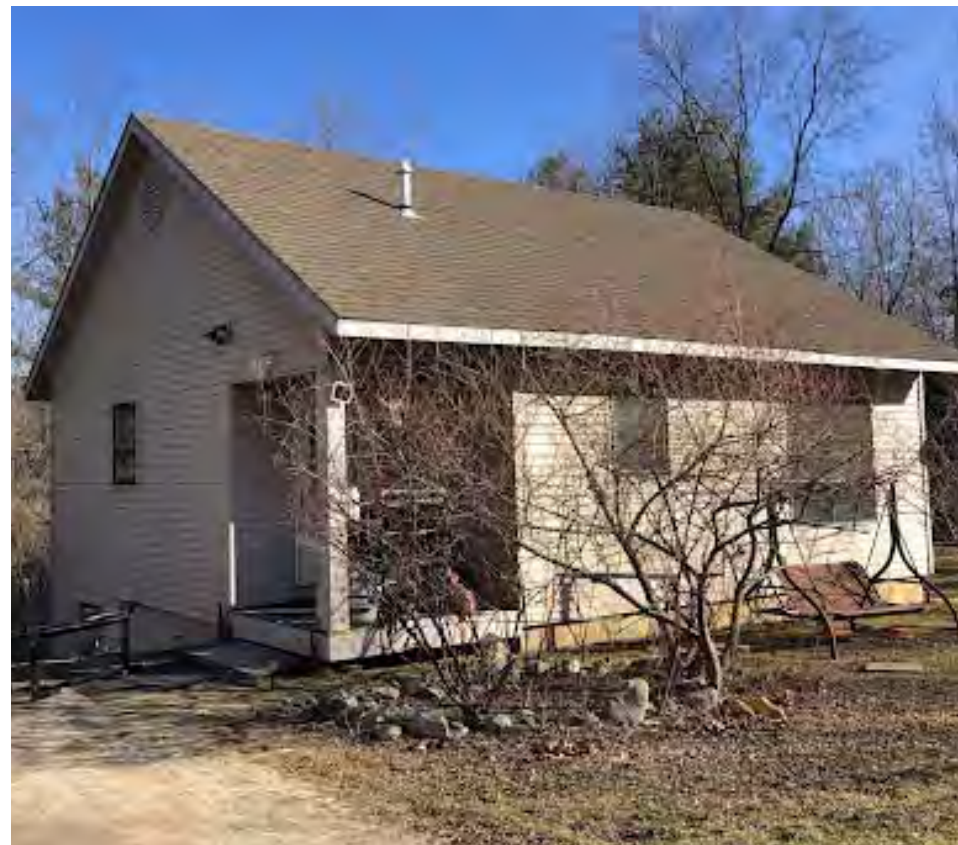
Southwest Elevation

- Steep pitch of terrain facilitates drainage
- Faces southwest with eave that successfully blocks summer sunlight.
- Large window to take in sunlight that also serves to light the entire upper level.

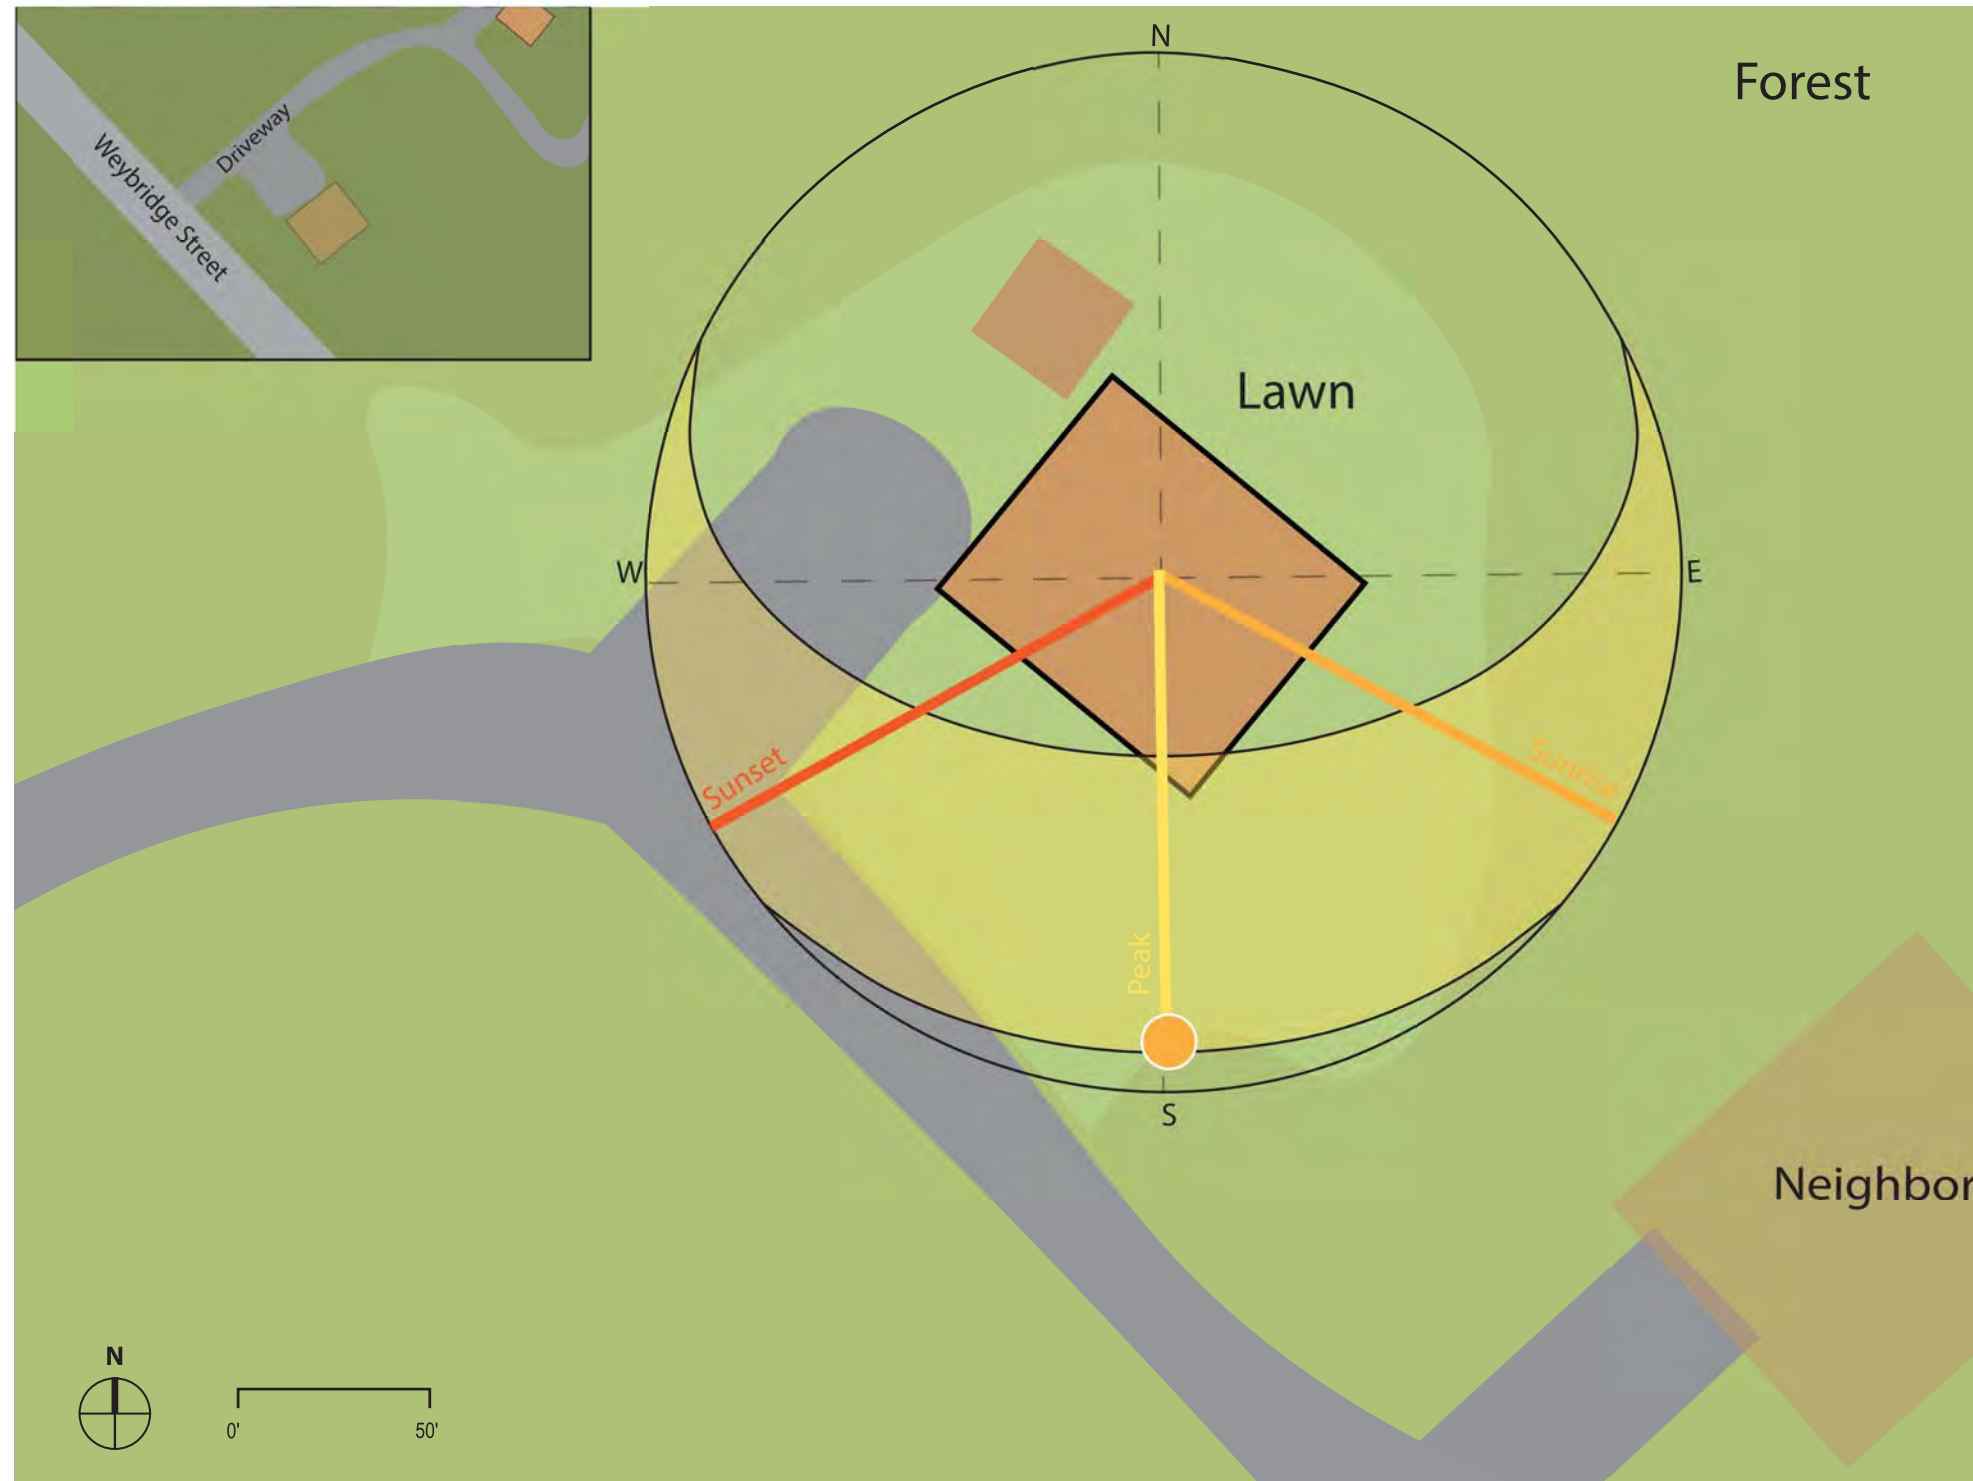
House Specifications

- Built 2010
- 3 BR
- 1.5 BTH
- ~1,000 SF
- Lot Size
- Hardie-board clapboard siding
- Gable Roof
- Single story

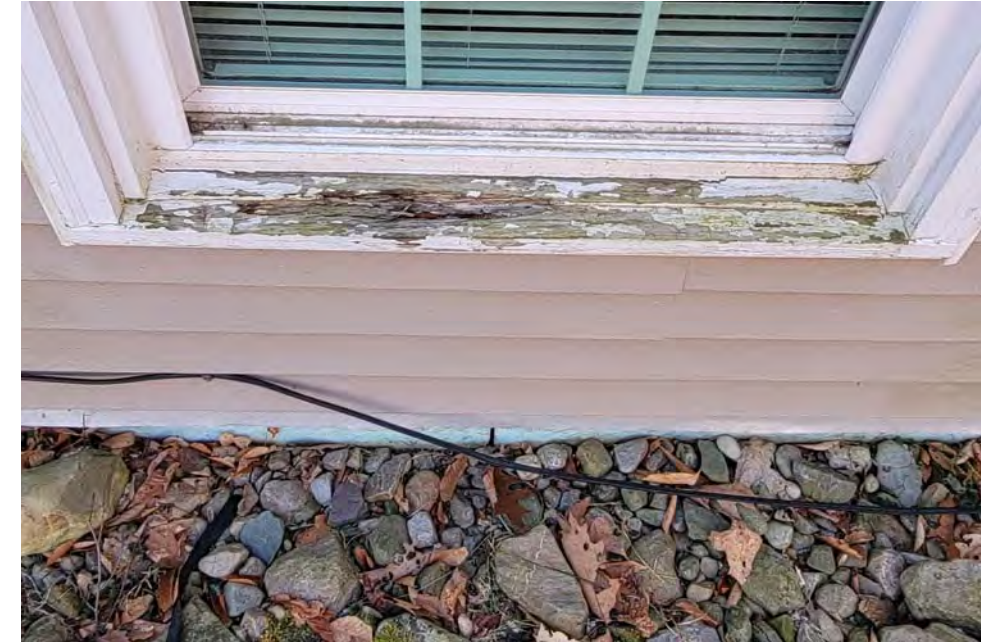
Weathering on Window

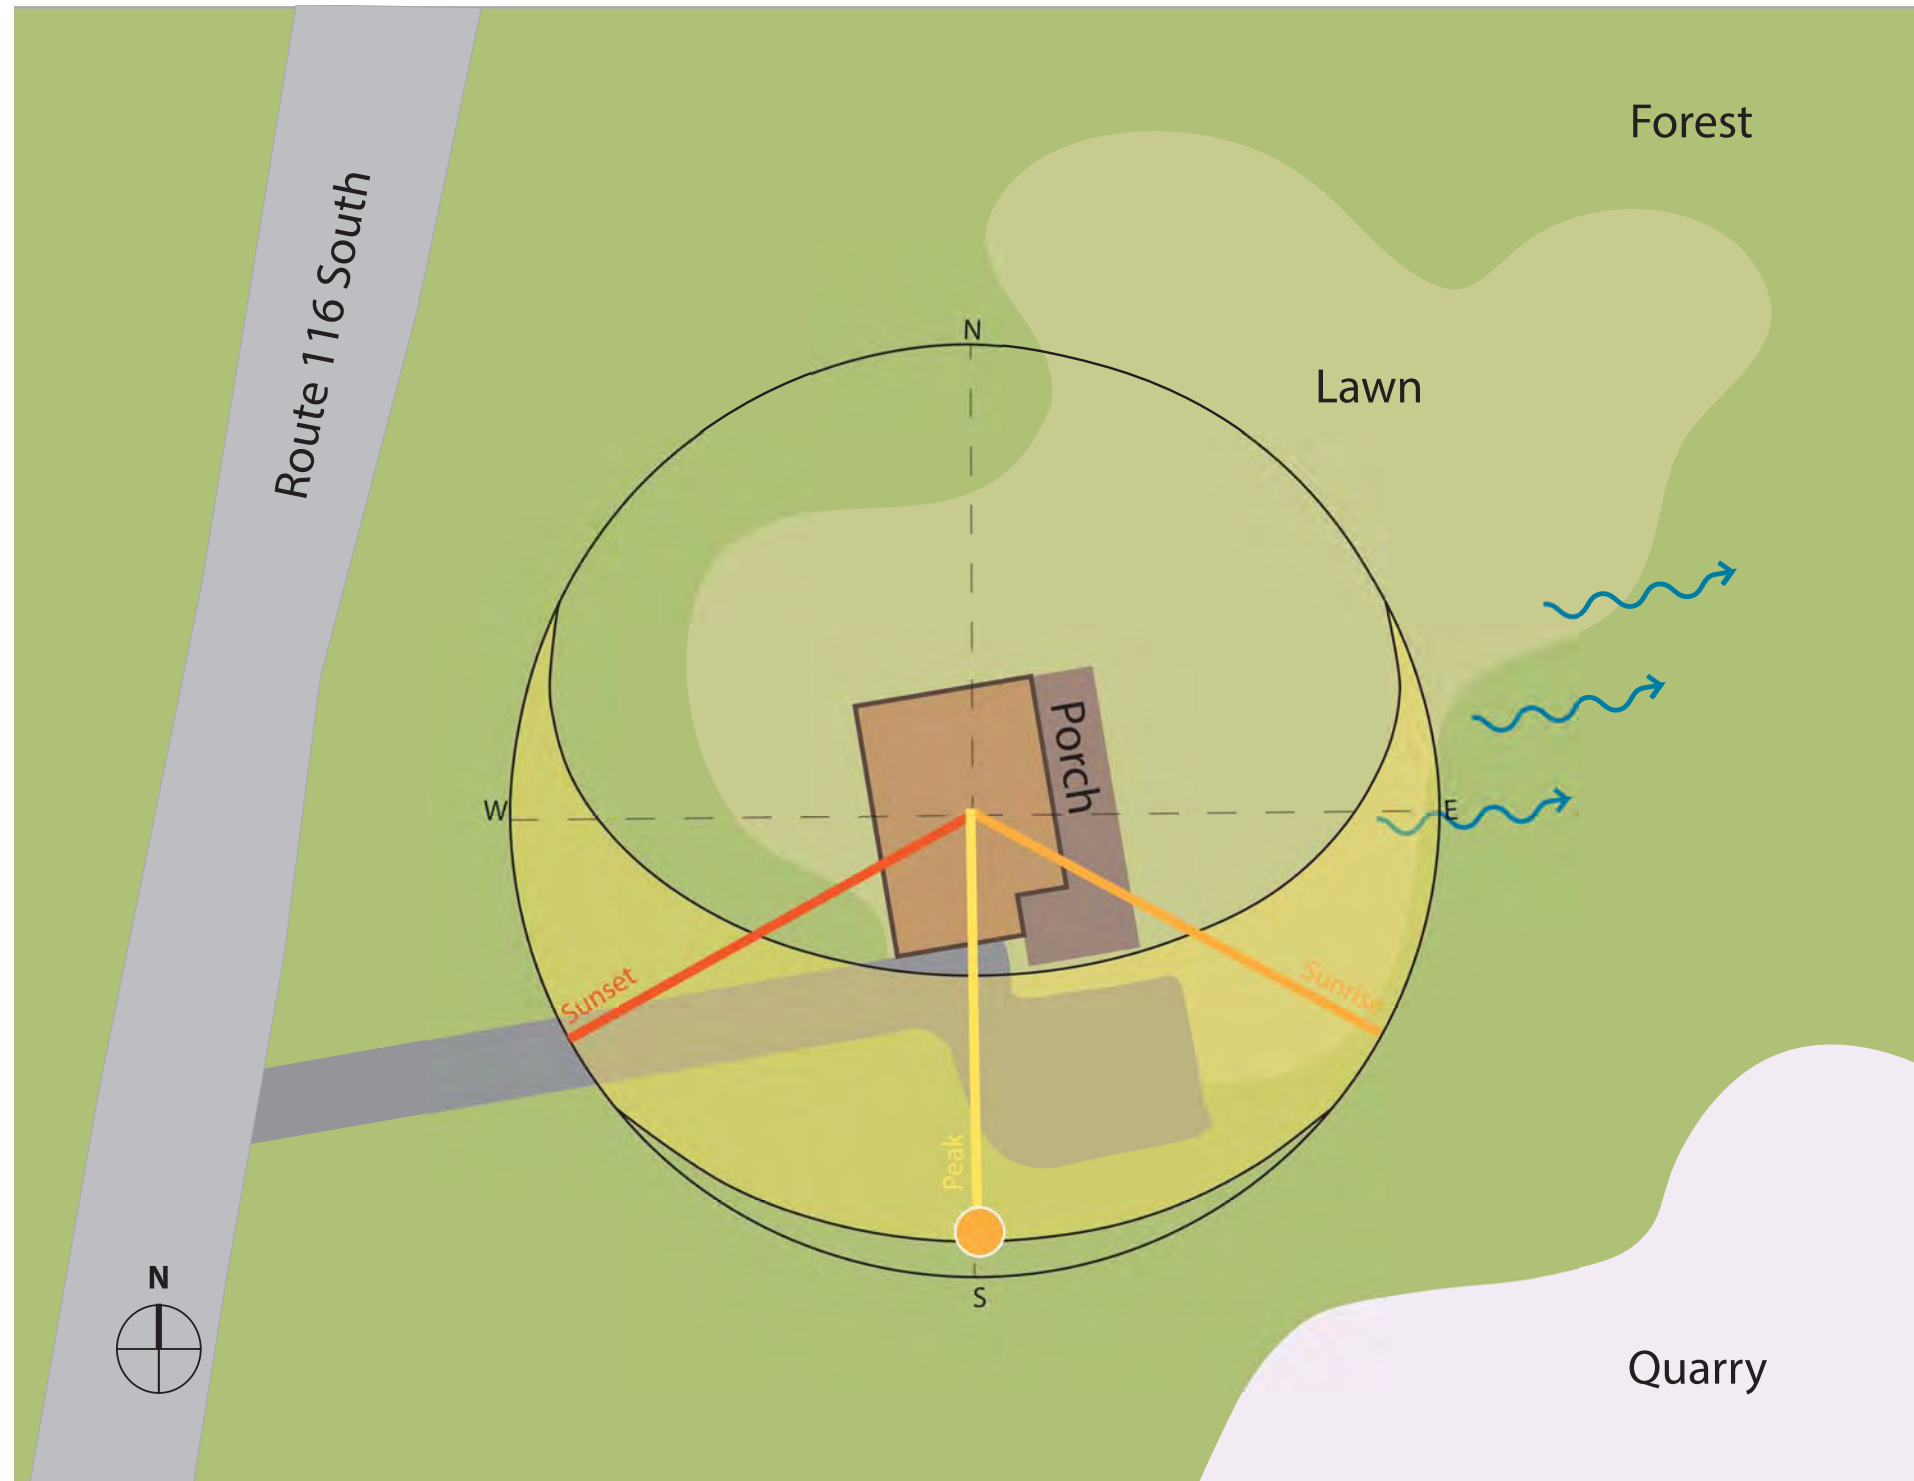
House Specifications

- Built 2001
- 4 BR
- # BTH
- 1,748 SF
- Lot Size
- Vinyl siding w/ wooden window frames
- Gable Roof
- 2 Stories

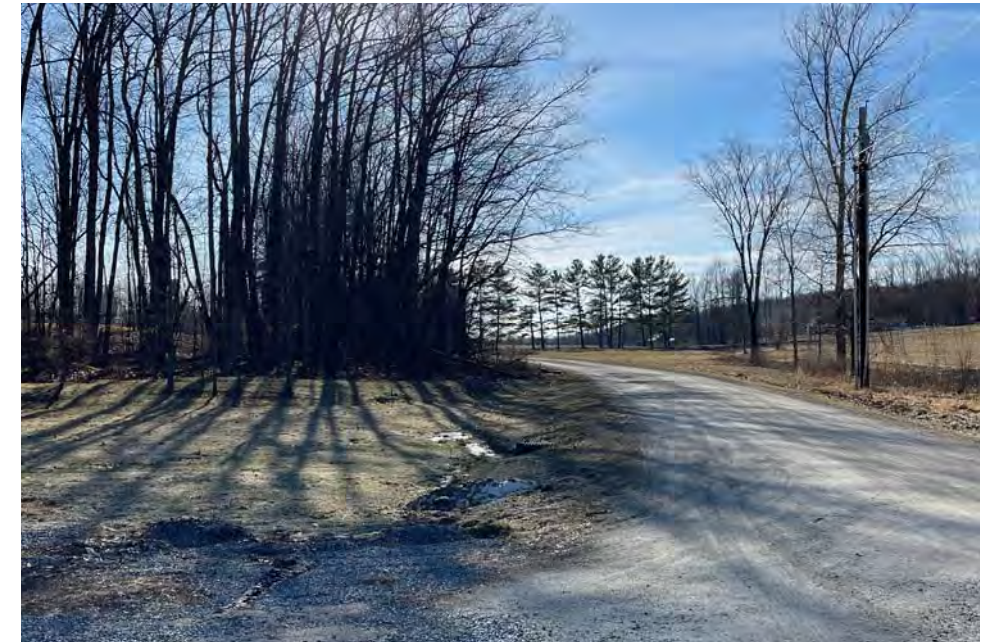
Road off Driveway

- Slight slope to terrain to facilitate drainage, but flatter than neighboring houses
- Drainage pipe underneath driveway is exposed and damaged

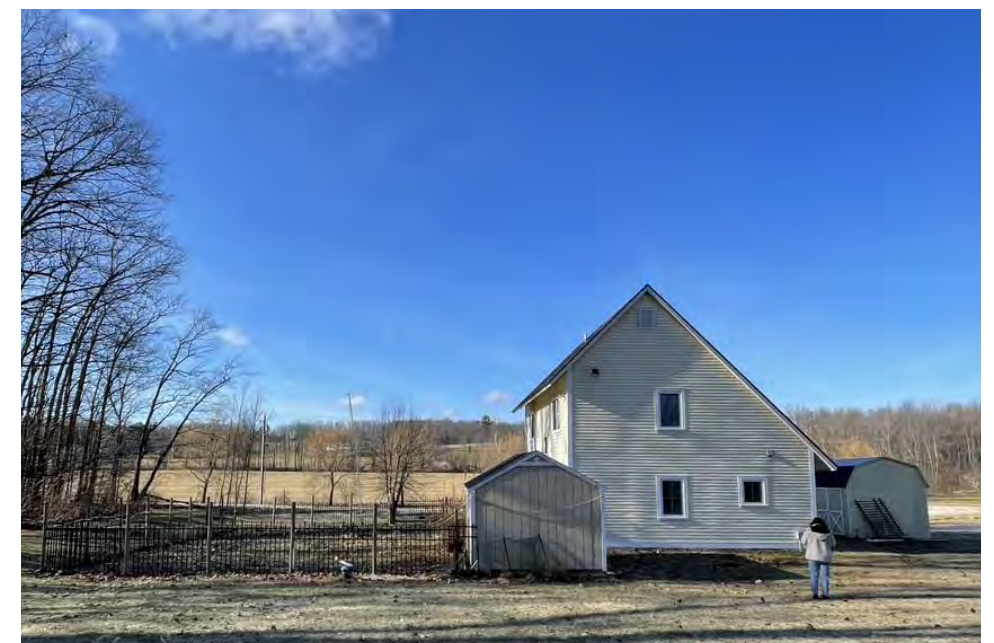
East Elevation

- Southside has 11 windows to take in sunlight
- During winter, the trees to the south block a fair amount of sunlight
- Eave protects upper level from overheating due to summer sunlight

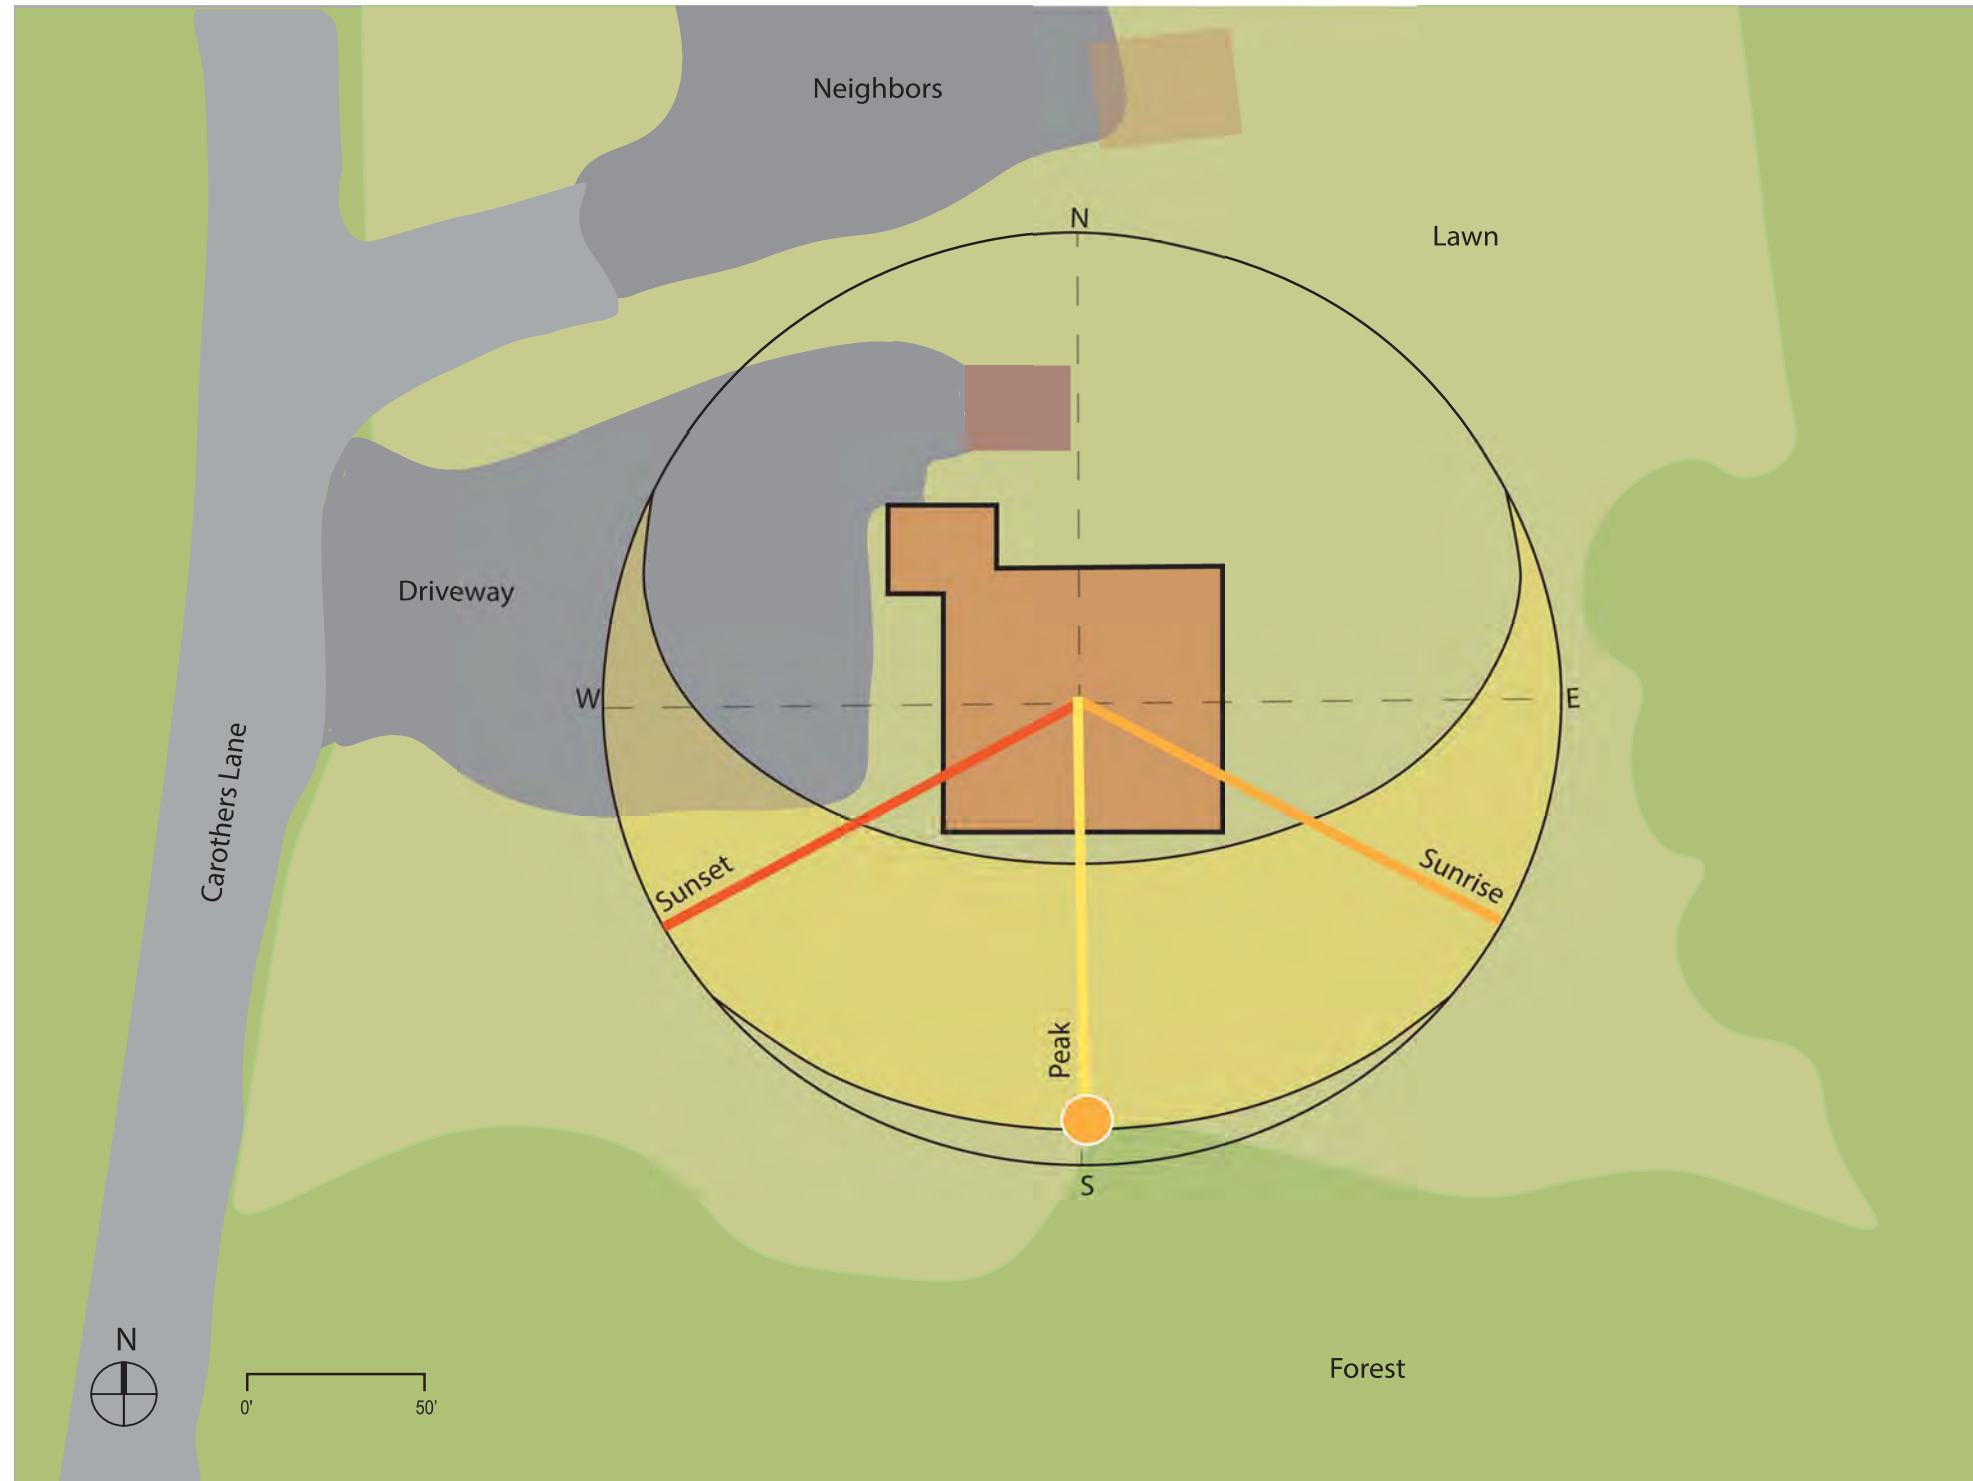
116 Carothers Lane House #6

- Built 2013
- 3 BR
- 2 BTH
- 1,200 SF
- Lot Size
- Hardie-Board clapboard siding
- Gable roof
- 2 stories

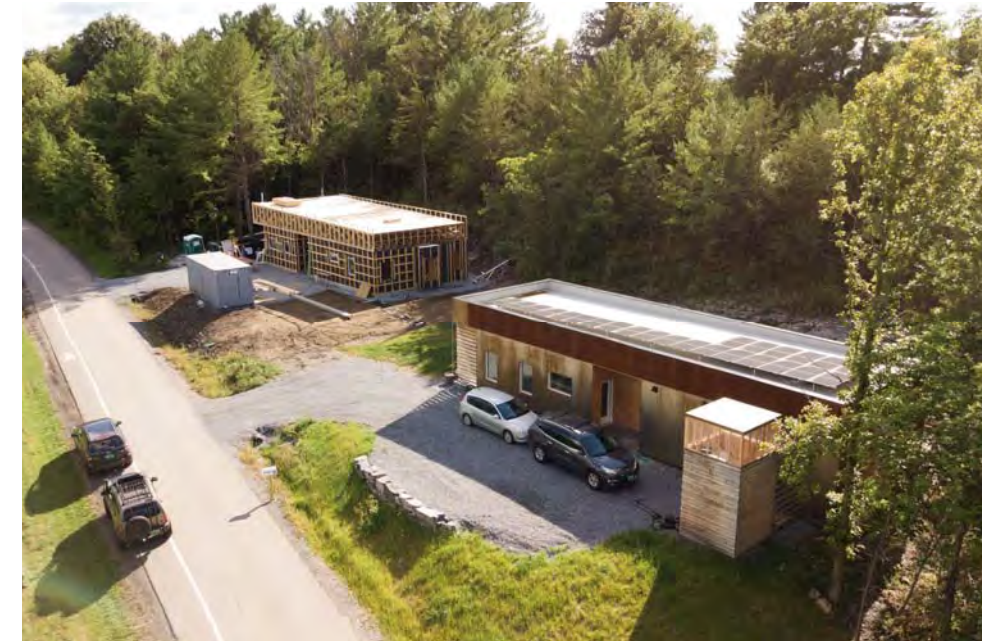
Roof

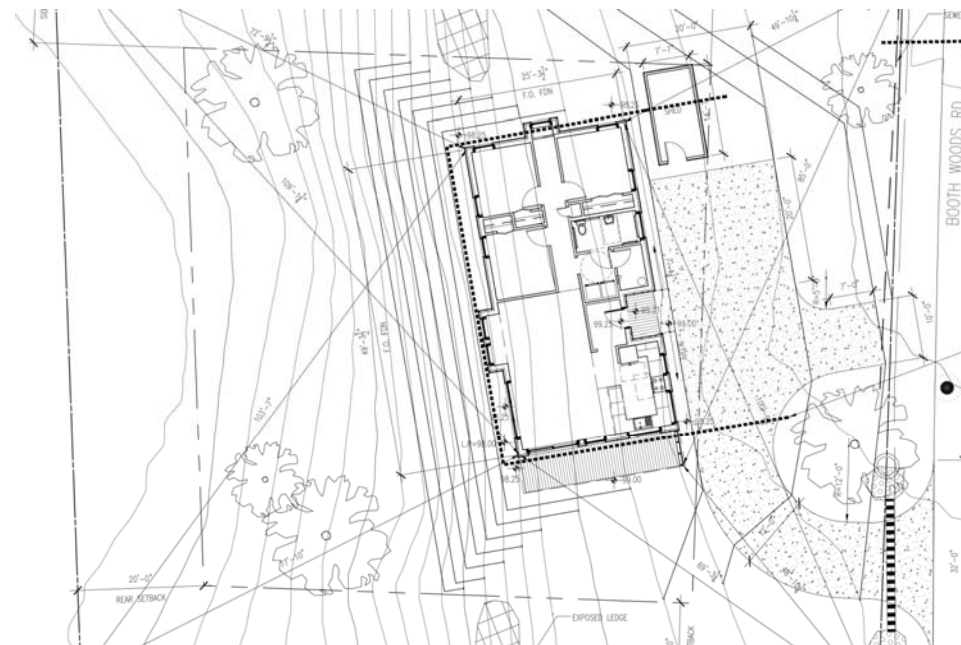
Floor Plan

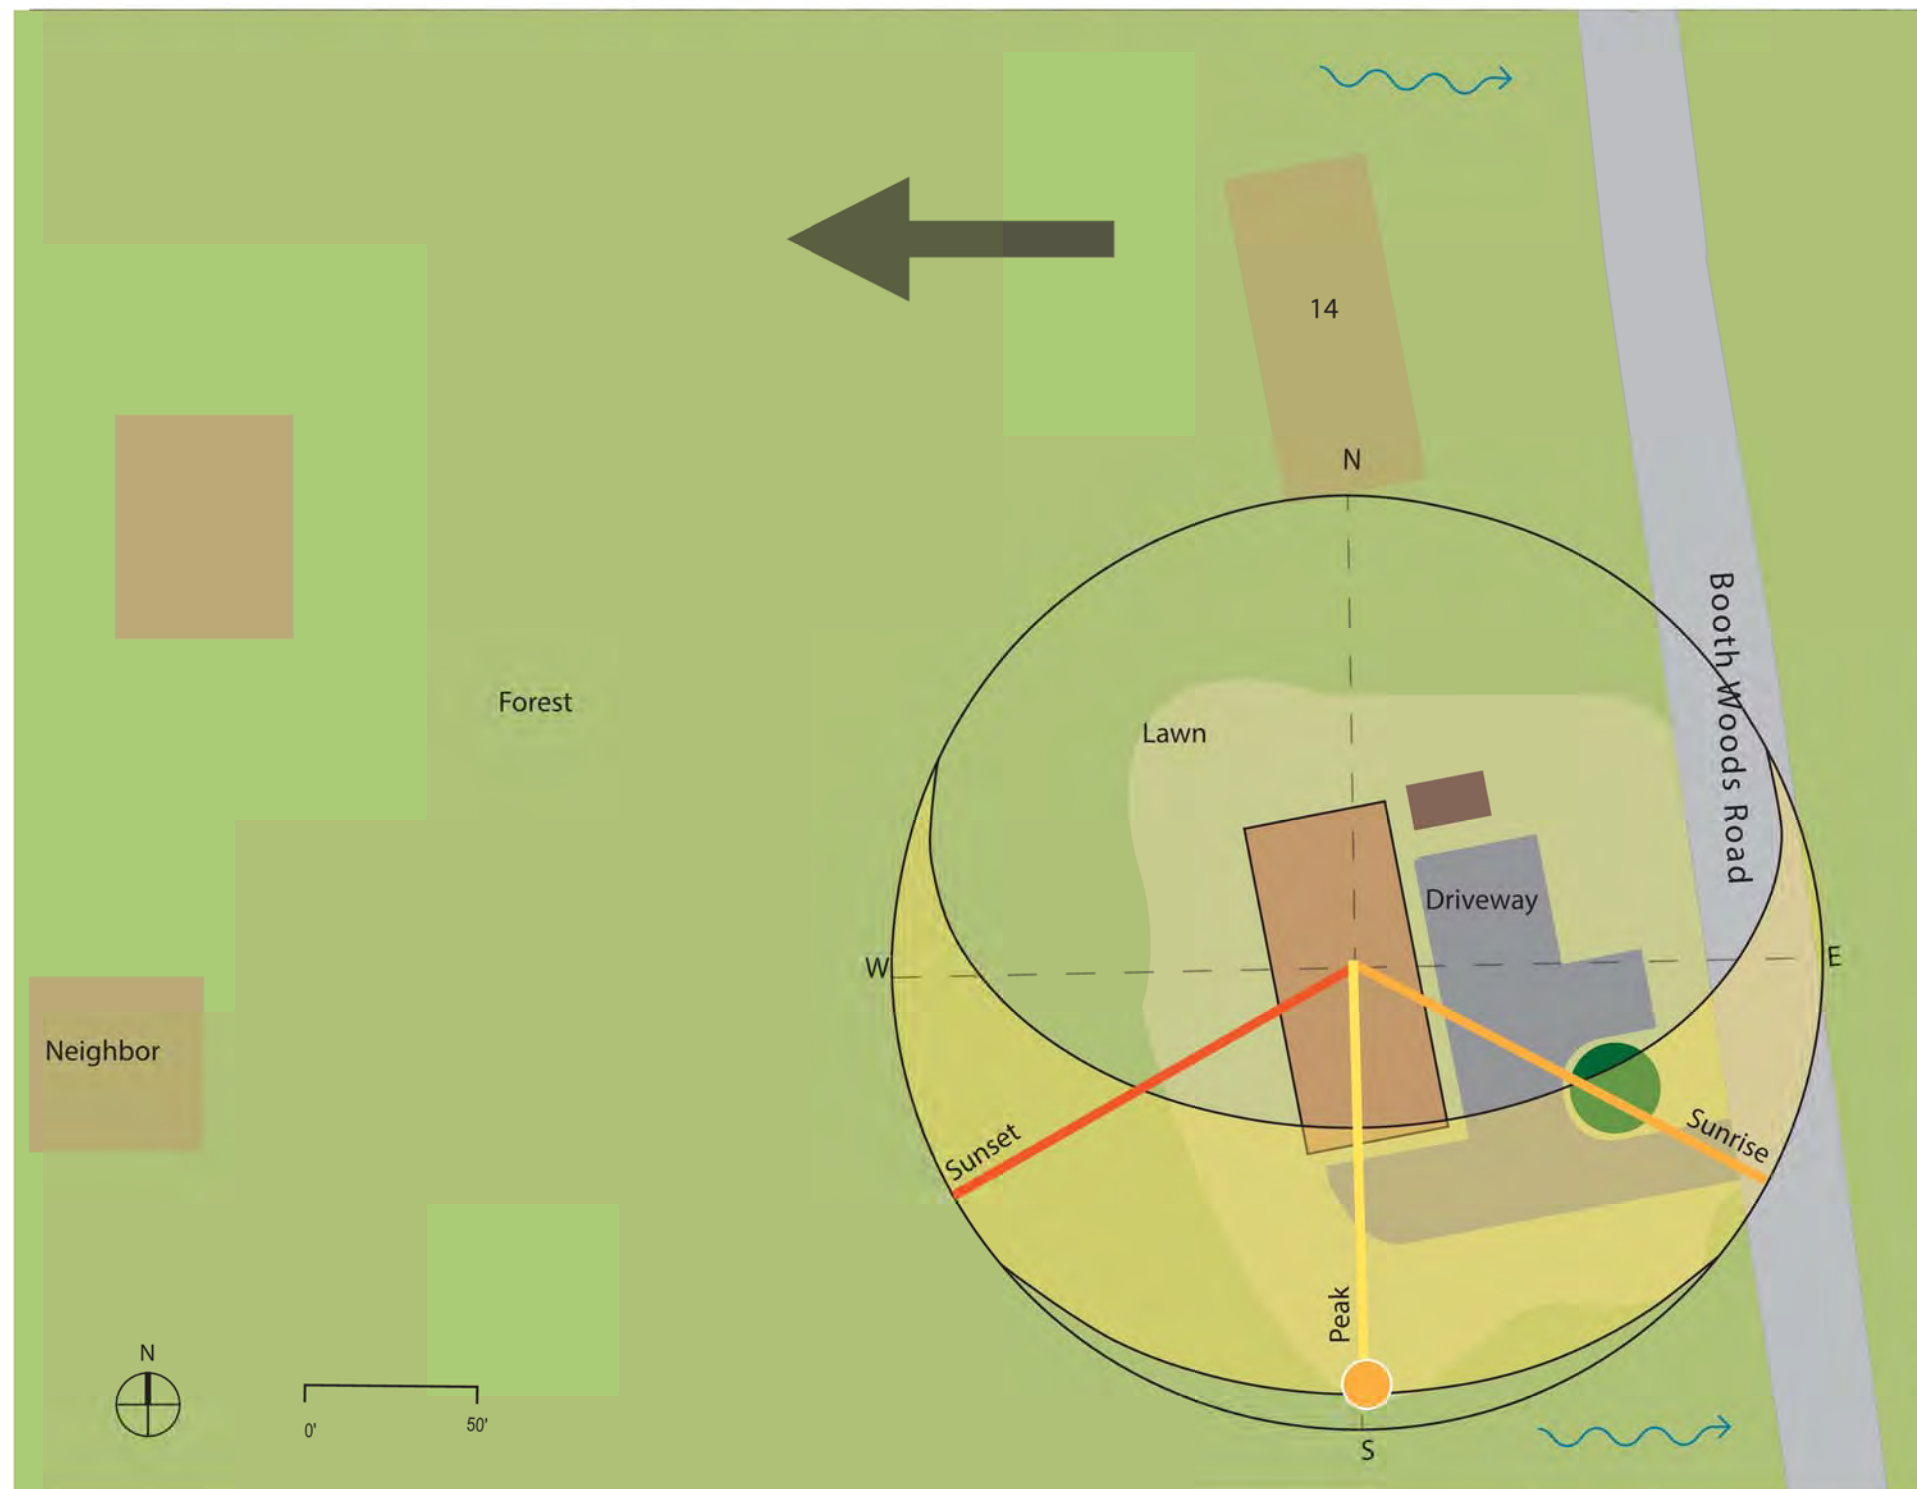
16 Booth Woods House #14 (Under Construction)

- Under construction, expected finish date May 2023
- 3 BR
- 1 BTH
- 1,206 sq. ft.
- Lot Size
- Black metal siding and plywood siding
- Flat roof
- Single story
